Analysis of the cross section of Palma de Mallorca Cathedral

Spain /14th Cent.
Project data

Structural type:
Gothic Cathedral. Limestone Masonry
Location:
Palma de Mallorca
Opening Date:
14th century
Proprietor:
Chapter of the Cathedral of
Palma de Mallorca
Scope of Works:
Structural Diagnosis

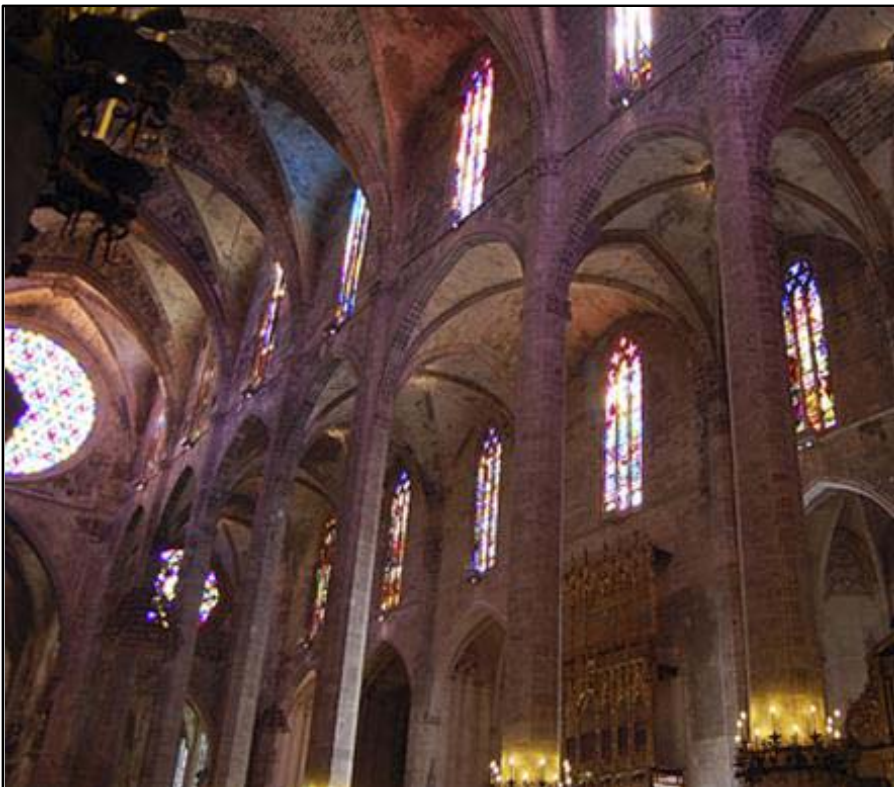
The columns of Palma de Mallorca Cathedral, which are the slenderest in the Gothic world, showed curvatures in the cross section plan as well as other damage (vertical cracks amongst others). This study was needed in order to establish the Management Program of the Cathedral. Likewise, disorders in the thrusts were also detected.

The structural analysis allowed an estimation of the safety level of the columns expressed in terms of relation between failure and acting stress eccentricities. The safety level determined was deemed to be adequate. In this study, the importance of the consideration of the construction process has been shown. With regard to the thrusts, whose analysis required fairly simple tools, (stability and tensional verification with non-tension materials) the study concluded that the stability of these elements would not be compromised whilst there were no movements in the abutments.

In any case, the need to develop an intelligent monitoring plan was observed in order to follow through and control the evolution of the most significant parameters.
