Bridge over the Rialbo River. Campo, Huesca

Spain / no date
Project data

Structural type:
Limestone masonry arch bridge
Location:
Campo, Huesca
Proprietor:
Ministry of Public Works
Scope of Works:
Strengthening, widening, and
repair project

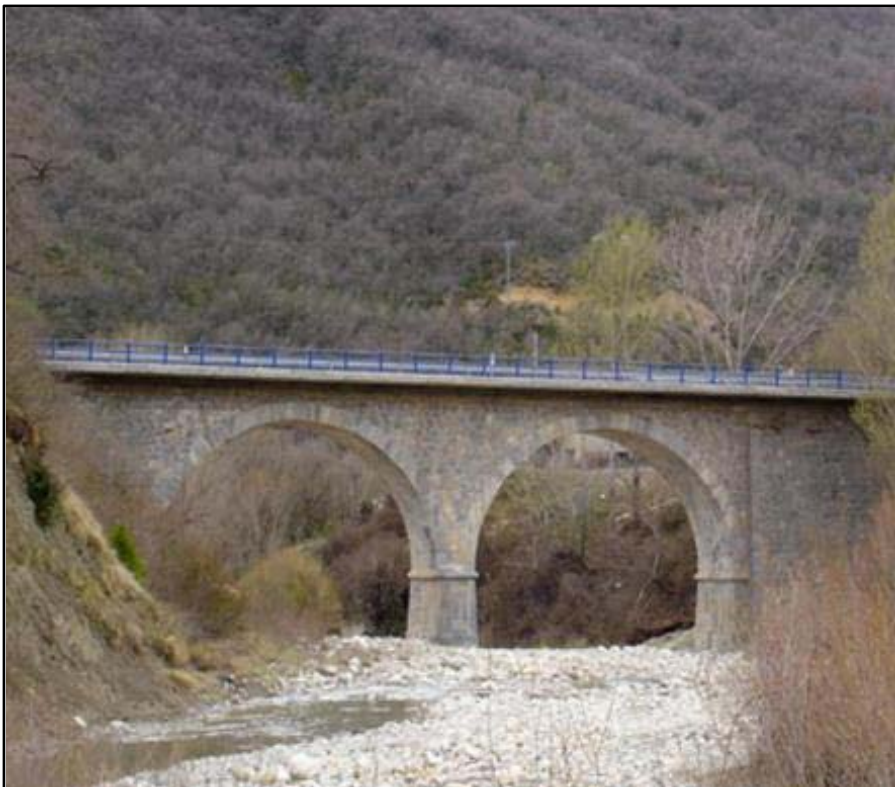
The main repair works are to be carried out on the vaults, and on the upstream side of the Campo bank abutment. On one hand, vaults show a certain amount, roughly ten, of damaged ashlar stones, especially on the Foradada del Toscar bank vault. These damaged ashlar stones have lost a significant percentage of their cross section. On the other hand, some ashlar stones are missing in the abutment, where a small well has appeared and may progress further in the nearby future, but as yet has affected the foundation unit. Replacement of masonry stonework and specific protection of these elements has been projected, as well as other specific actions such as; cleaning, removal of vegetation, consolidation, re-pointing and application of water-repellent products to the masonry work.
