The Isle of Arosa Bridge Repair Project

Spain /2007 Project data

Structural Type:
2,000m long Pre-tensed
joint-free concrete box
Location:
Access to the Isle of Arosa, Pontevedra
Date of Works:
2007
Proprietor:
Galician Regional Government
Scope of Works:
Special Inspection and Repair Project

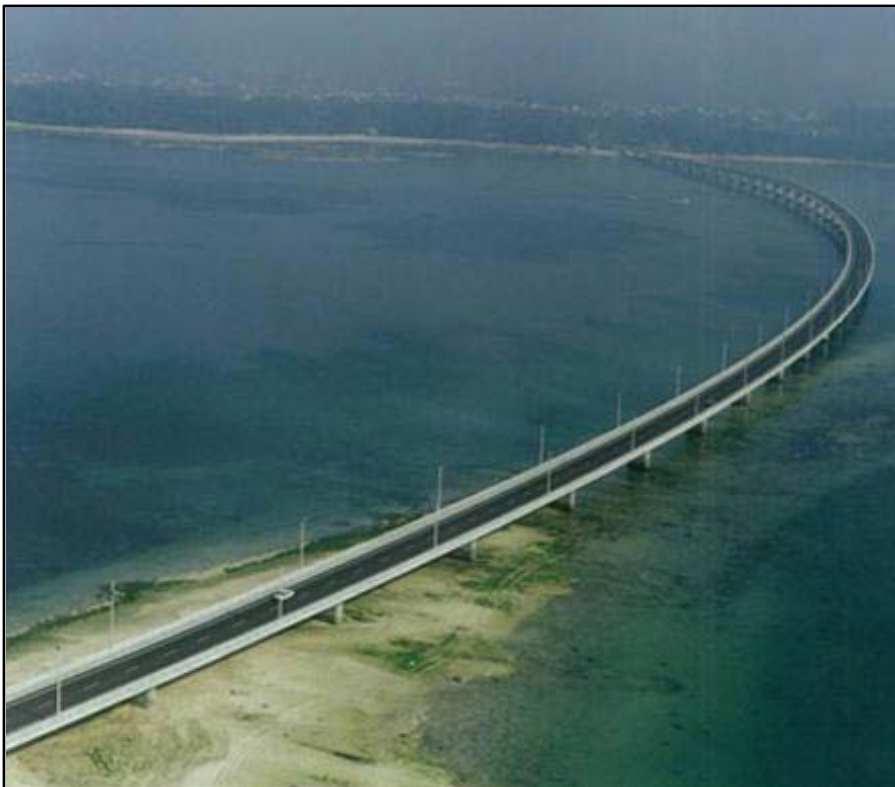
- Injection of the fissures in the box girder, and sanitization of the corroded metalwork on the lower part of the box, pier area, abutments and walkways adjacent to the bridge on the landside area. Fulfillment of repair works in said areas prior to the introduction of sacrifice anodes which impede surrounding areas becoming future anodes, susceptible to corrosion associated with the projected repair areas.
- Repair of gravel beds in the pier areas.

- Placement of sacrifice anodes in the tidal area and submerged areas, with the placement of a zinc mesh upon the shaft and a mortar cast in the space left between the face and a fiberglass mould bolted to the face.
- Painting of all external faces of the deck, abutments and piers (except those areas above high-tide level which are covered with the fiberglass moulds) with a waterproof, chloride-based paint, but which allows the drainage of internal water vapors. This strategy increases the resistance of the concrete and hence decreases the intensity or speed of corrosion and consequently the useful life of the structure.
- Painting of the inside of the box.
- Cleaning of support plates and protection with paint and repair of the neoprene bases in case of deterioration.
