Ponteceso Bridge

Spain /1879 Project data

Structural type:
Masonry Arch Bridge
Location:
Ponteceso. La Coruña
Opening date:
May 26th 1879
Proprietor:
Xunta de Galicia
Construction:
Autumn 2004
Scope of Works:
Restoration, widening, strengthening

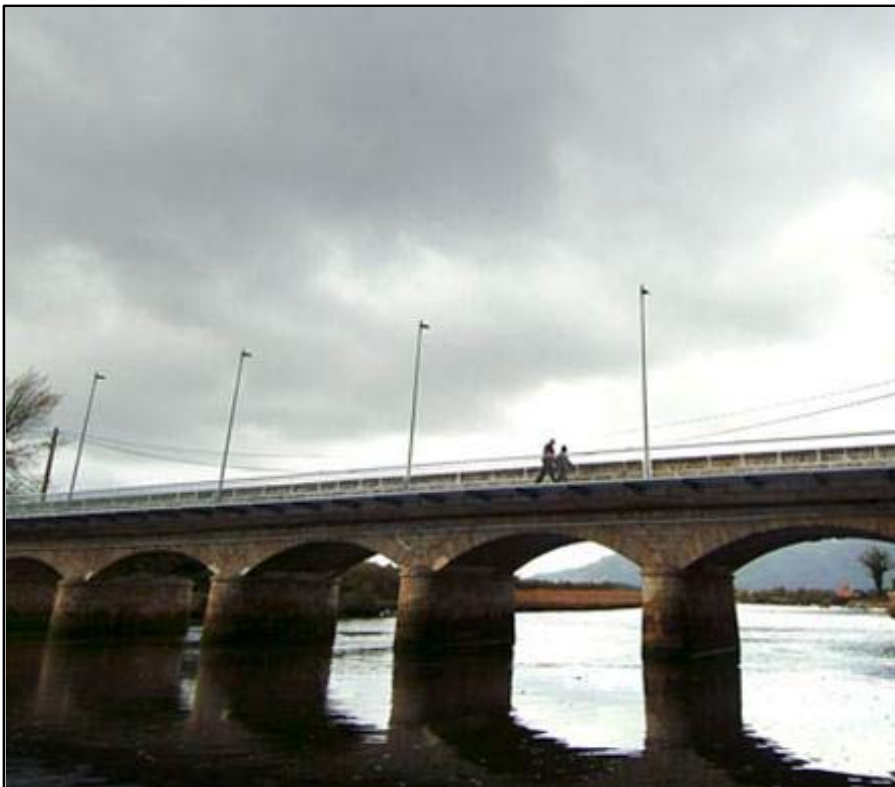
The Ponteceso Bridge is an Ashlar masonry arch bridge erected at the end of the nineteenth century. It is 50.0m long, and is composed of five vaults, spanning 10.0m between pier axis and an 8.50m free span at the maximum points of the barrel. The bridge has four piers which are set in the flow of the river. The vaults are 0.70 m thick and 6.00 m wide. All the bridge was erected in granite Ashlar, which remain in a good state of repair. Piers and abutments are foundationed on wood piles, upon a low bearing capacity soil. The current bridge deck is too narrow to allow road and pedestrian traffic to run smoothly.

Widening of the bridge, now reaching 8.95m, was designed asymmetrically, so that one of the elevation views of the bridge remains intact, thus meeting patrimonial requirements. Widening was fulfilled using a concrete slab on top of the bridge's back. The slab is 7.05m wide and 0.30m deep, and will bear road traffic. A gridded steel walkway, resting on steel ribs spaced every 2.0m and connected to the slab, will support pedestrian traffic. The steel ribs are connected to the slab without affecting or touching the spandrel walls, resulting in a cantilever length of 3.47m.

Foundation strengthening consisted in the drilling and execution through piers and abutments with micro-piles, crossing through the aforementioned soil layer, reaching subjacent rock strata.
