# Balaidos Stadium roof structure reinforcement study

Vigo, Spain / 2017-

Structural type  
Characteristics  
Client  
Constructor  
Scope

reinforced concrete structure for changing the existent roof by a lighten one  
feasibility study for different solutions which could resist Balaidos Stadium roof change  
COPASA  
COPASA  
detailed design and construction support

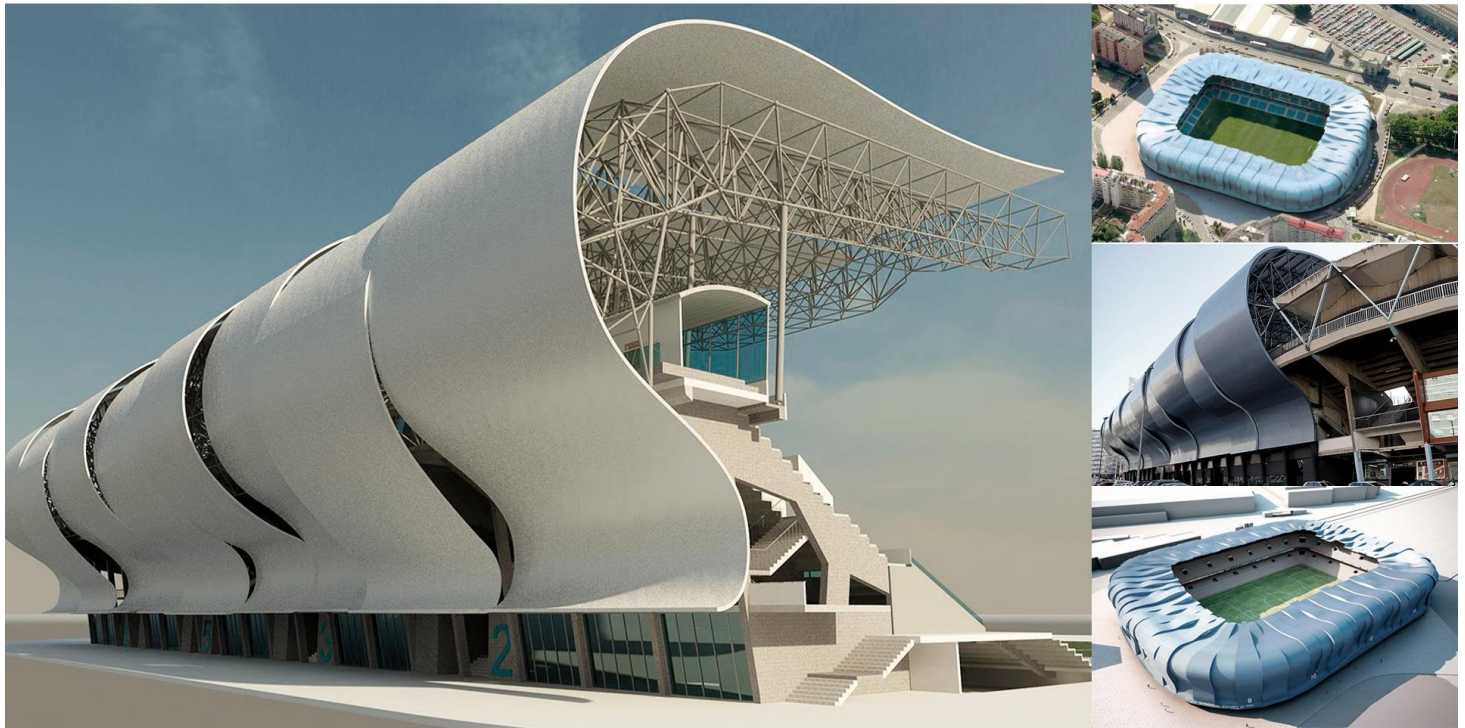
Balaídos stadium (Vigo, Spain) was built in 1960. In this year, three grandstands were executed (grandstand "Goal", grandstand "Scoreboard" and grandstand "North"). Subsequently, and on the occasion of celebration of the World Cup, the grandstand "River" was built in 1981 to complete the stadium. The structure built at the beginning of the 60s consisted of reinforced concrete frames every 5.65m and the roof consisted of reinforced concrete shells. The cantilever span of the roof is 17.00m and the distant between support point on the frames is 4.50m. The grandstand "River" built later consists of reinforced concrete frames (columns and beams) every 8.40m of greater importance. Roof consists of a light 3D steel structure formed by spherical joints and tubes. Roof cantilever span is 22.40m and the distance between supports on the frames is 11.20m.

A remodeling of the stadium has been proposed in different phases. The first phase of the remodeling focused on the grandstand "North". The remodeling consisted in the extension of the grandstands towards the playing field and the replacement of the concrete cover roof a new high steel roof up to 25.80m cantilever in order to cover the entire extension of the new stands. The new roof supports a new architectural skin that also extends in continuity with the façade, which changes from being a wind-permeable roof to a closed structure. This radical modification of the roof totally modifies the reactions on the concrete frames since the wind exposure is much more conditioning.
