Palma de Mallorca Cathedral cross-section analysis

Palma de Mallorca, Spain / S. XIV

Structural type Owner Scope gothic cathedral, limestone masonry (sandstone Cabildo de la Catedral de Palma de Mallorca auscultation and diagnosis

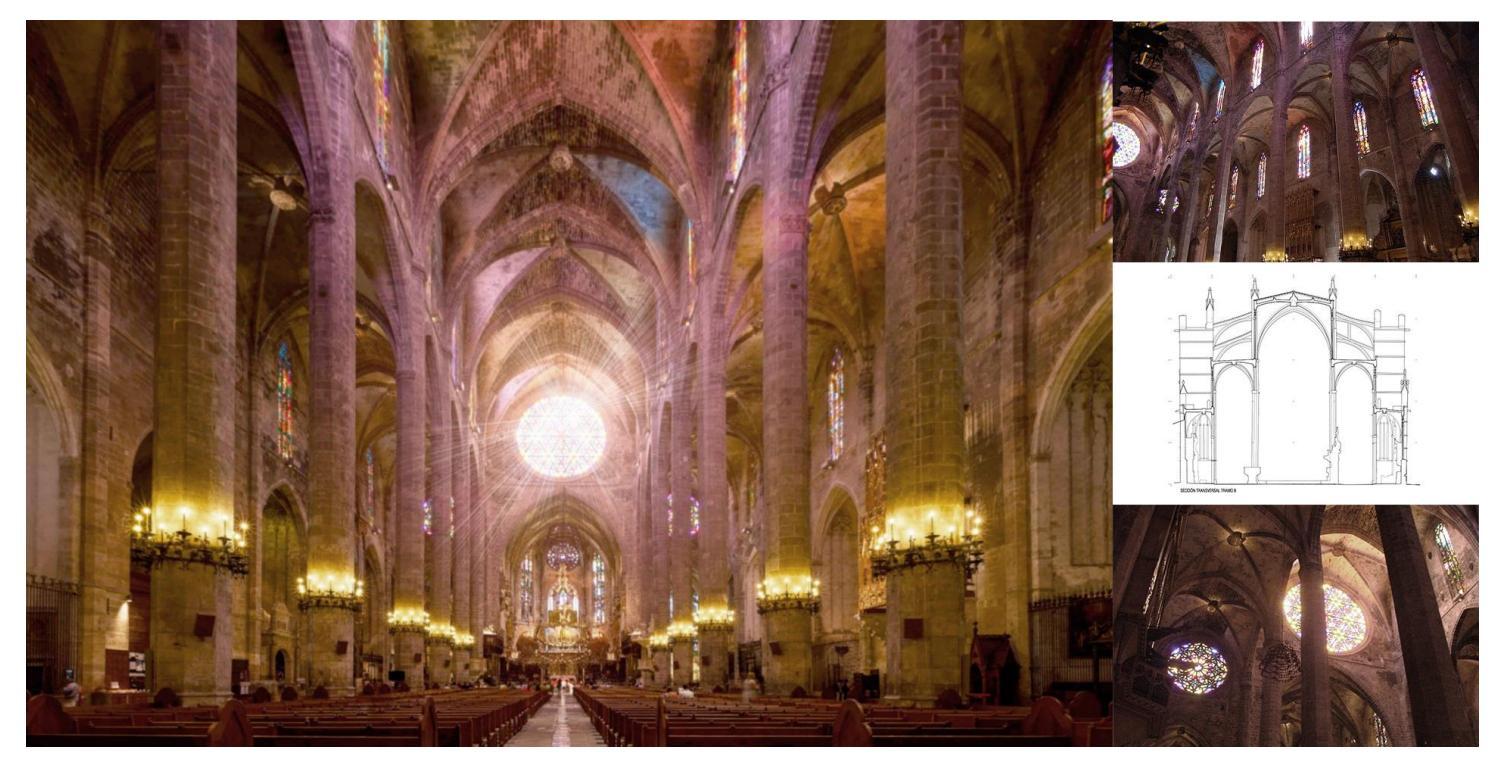
The columns of Palma de Mallorca Cathedral, which are the slenderest among Gothic Cathedrals in the world, showed curvatures in the vertical cross section as well as other damage (vertical cracks amongst others). This study was needed in order to establish the Management Program of the Cathedral. Likewise, disorders in the flying buttresses were also detected.

In order to find an answer to this problem, an analytical study of the cross sections structural behaviour was fulfilled. The mechanical behaviour of the masonry had to be characterized, as without recognizing the masonries and their resistant capacity, the degree of the columns' stability could not have been determined.

The structural analysis allowed an estimation of the safety level of the columns expressed in terms of relation between failure and acting stress eccentricities. The safety level determined was deemed to be adequate. In this study, the importance of the consideration of the construction process has been shown. With regard to the thrusts, whose analysis required fairly simple tools, (stability and tensional verification with non-tension materials) the study concluded that the stability of these elements would not be compromised whilst there were no movements in the abutments.
