# Restoration of the Ancient Convent of San Francisco

Mondragón, Gipuzkoa, Spain / 2002-2004

masonrywork and composite structure  
Ayuntamiento de Mondragón  
Construcciones Amenábar  
repair / strengthening project

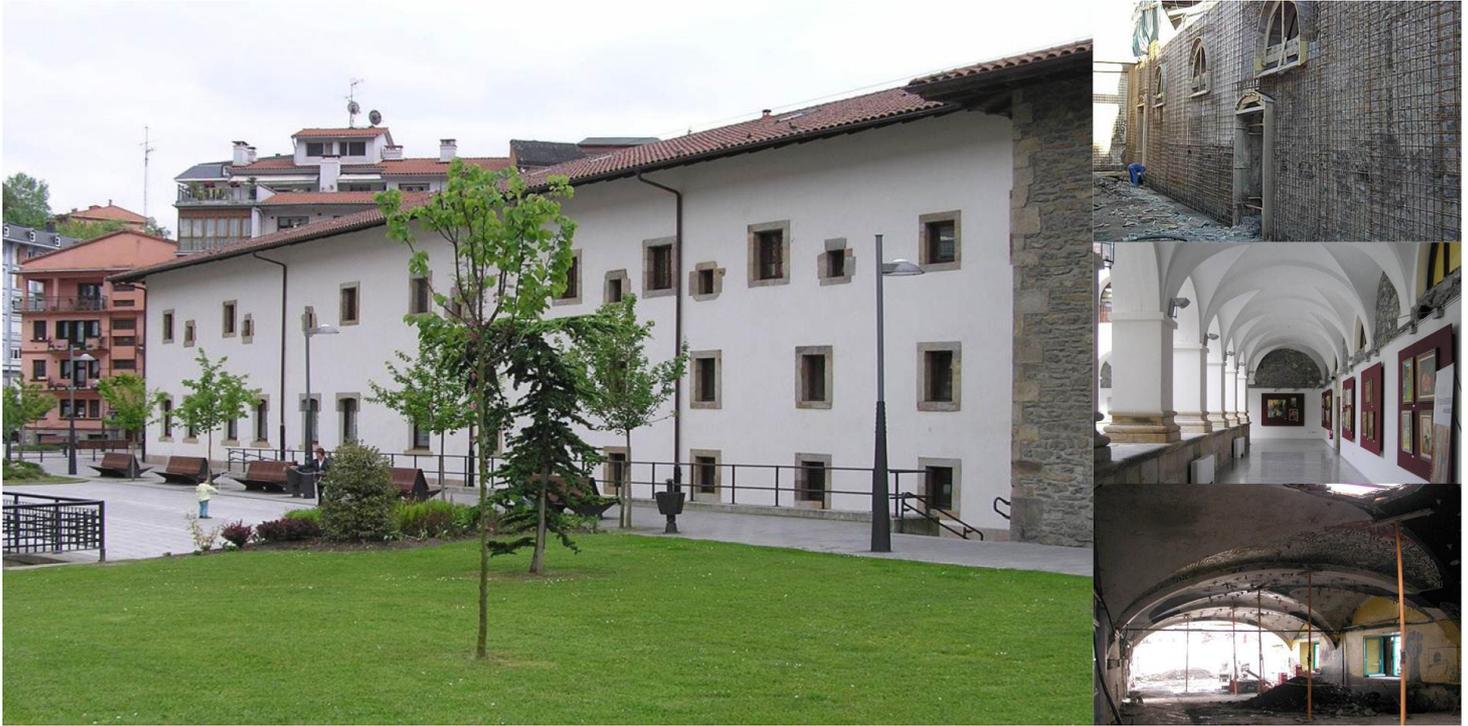
In November 2002, once rehabilitation works were already under way governed by a previous project, the need for substantial changes arose. On one hand, the reason for these changes was based on the structural configuration of the masonry walls and the brick pilasters set on a stone base. On the other hand, the new and considerably higher loads which needed to be transferred to an adequate stratum base given the deficiencies detected in the existing foundation.

The best all-round solution to these problems was the underpinning of the foundations employing micropiles and pile-caps onto which the new walls would be set.

The extrados of the vaults was carefully emptied and followed up by the propping of the most affected elements in order to reconstruct the worst of them afterwards.

Special attention was paid to the strengthening of the brick pilasters. In fact, they were not actually strengthened but, instead, perforated micropiles were, very precisely, threaded into the pilasters from a platform constructed above. Hence, the new horizontal structure could be connected to these aforementioned micropiles, freeing the old brick work pilasters from their bearing function.
