Rehabilitation of the España Building

Spain /2010 Project data

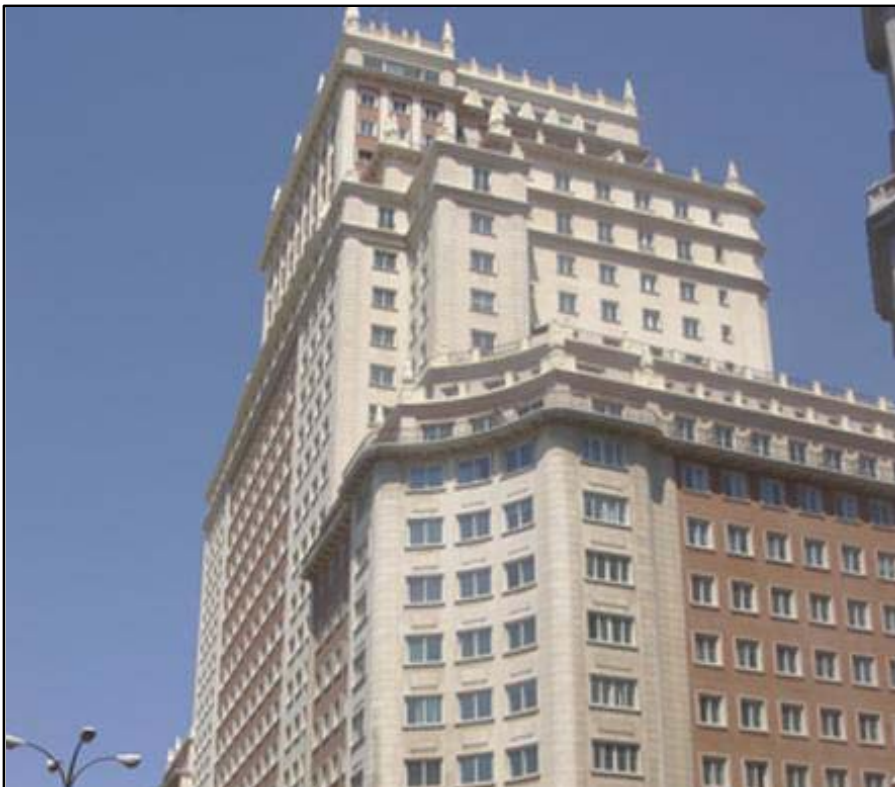
This emblematic building situated in the Plaza de España in Madrid, dates back to the middle of the 20th Century. It is constructed with reinforced concrete perimeter walls and columns which employed smooth rebar. The horizontal structure is composed of one-way slabs resting on reinforced beams with the same rebar type. The foundation unit is composed of surface rectangular-shaped footings which taper and stagger upwards.

This is a structural and functional rehabilitation Project, which consists of repairing the damaged elements so as to enhance their durability and of opening and closing openings to change the distribution and use of the building. Below grade, the structure shall be reinforced so as to allow a new car parking level, for which it will be necessary to eliminate a few perimeter columns to enable the construction of the new access ramps to the lower levels.
