## Rehabilitation of nº6 in the Calle Salustiano de Olózaga

### Spain /2009 Project data

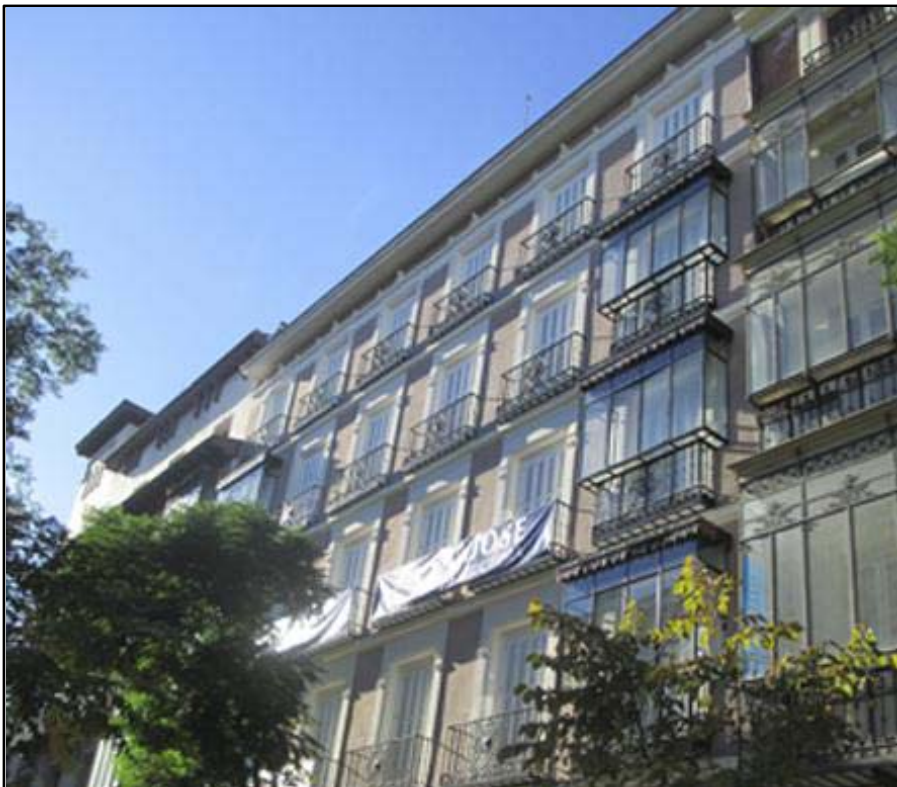
The building is located at Nº6 in the Calle Salustiano de Olózaga in Madrid and dates back to the 19th Century and is a perfect example of the noble construction of this period: Load-bearing walls composed of a framework of studs and sleepers, braced with masonry brickwork and lime mortar. These walls were normally arranged parallel to the main façade, acted as supports to the wooden joist flooring which made up the five floors of the building.

This is a global structural rehabilitation Project which in its first phase will stabilize and reinforce the structure on grade with a steel framework and in a second phase will excavate the building below grade so as to obtain three levels of car parking. The process will consist of micro-piling a slab on the first floor which will receive the loads from the building above grade and then consequently excavate the building below grade level.
