Rehabilitation and extension of bridges in las Gabias and la Malahá (A-338)

Spain /2010
Project data

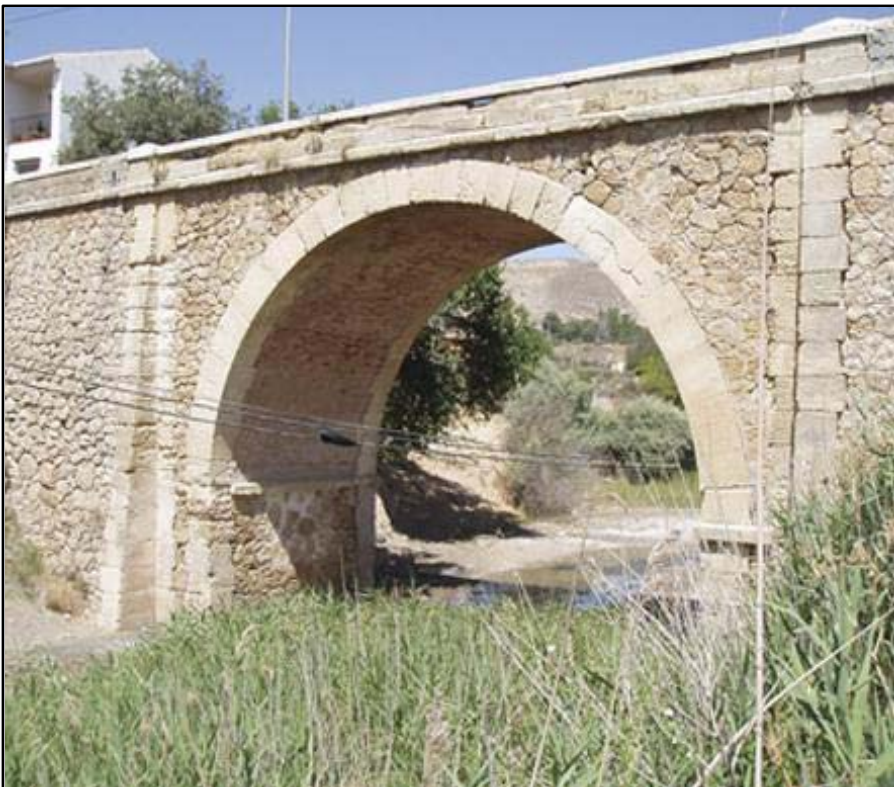
Pathologies associated to the presence of water in the stonework were detected, originating from either the water run-off or the capillarity. On the other hand, the loss of original cladding could be observed, separations between barrels and arches, pointing with Portland cement mortar, honeycombing of the brick vaults, etc.

The rehabilitation Works have centered on the cleaning of the face with high-pressure water, sealing of cracks, salt extraction, unit recomposition, general re-pointing, stonework consolidation with silicic acid esters and waterproofing with acrylic silicon.
