Bridge over the Veral River. Huesca

Project data

Structural type:
Limestone masonry arch bridge
Location:
Huesca
Proprietor:
Ministry of Public Works
Scope of Works:
Strengthening, widening, and
repair project

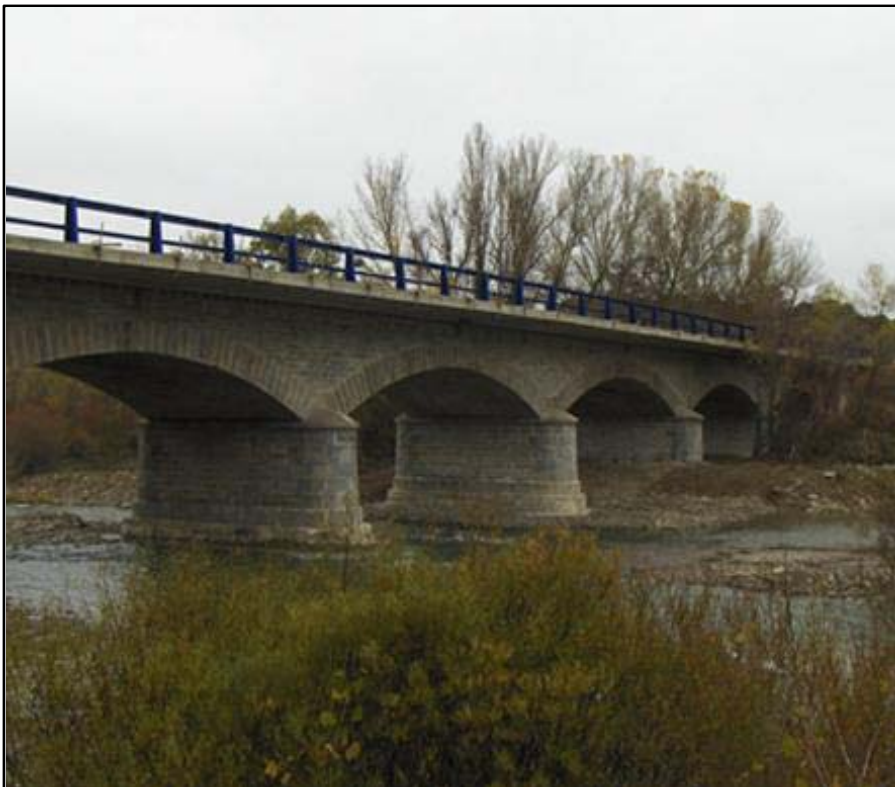
The bridge is composed of five circular, finely cut limestone ashlar masonry vaults which maintain a constant depth on the whole run of the arch. The bridge was designed by Gaztelu who at that time was Professor of Masonry Arch Bridges at the Special School of Civil Engineering in Madrid. Both design and construction took place in the second half of the XIXth Century. The bridge's total length is 80.40m, vaults are 6.00m wide, and vault spans are 15.00m. Pier heights are approximately 4.25m, whilst the width of the battered pier walls varies, at a ratio of around 1/10. The piers are crowned by conical masonry caps. The road elevation above the river bed is roughly 8.00 m.

Bridge inspections showed that pier integrity could be threatened due to the existence of significant

honeycombing and leachate fills. The dissolution of surface fill-material salts provoked by deficient drainage and waterproofing conditions, has resulted in the appearance of efflorescence in the barrels of the arches.

This 10.00m wide new cross-section is divided into two 3.50m wide lanes, plus two 1.00m wide verges and two 0.50m wide barriers. The drainage conditions are guaranteed by an effective camber in the pavement and new lateral drain installations.

The widened deck consists of a series of reinforced concrete slabs that rest on the back of the vaults with cantilever widths of 2.5m. As traffic flow could not be interrupted throughout the construction process it was fulfilled in the following way: The slabs were cast in successive semi-sections, which were freestanding throughout all the stages, thus respecting the areas to be concreted and the usage restrictions recorded on plan.

Plinth protection has been placed around each foundation element, as well as other specific treatments such as; cleaning, removal of vegetation, consolidation, application of water repellent products and re-pointing of masonry-work.
