# Palma de Mallorca Cathedral cross-section analysis

Palma de Mallorca, Spain / S. XIV

gothic cathedral, limestone masonry (sandstone)  
Cabildo de la Catedral de Palma de Mallorca  
auscultation and diagnosis

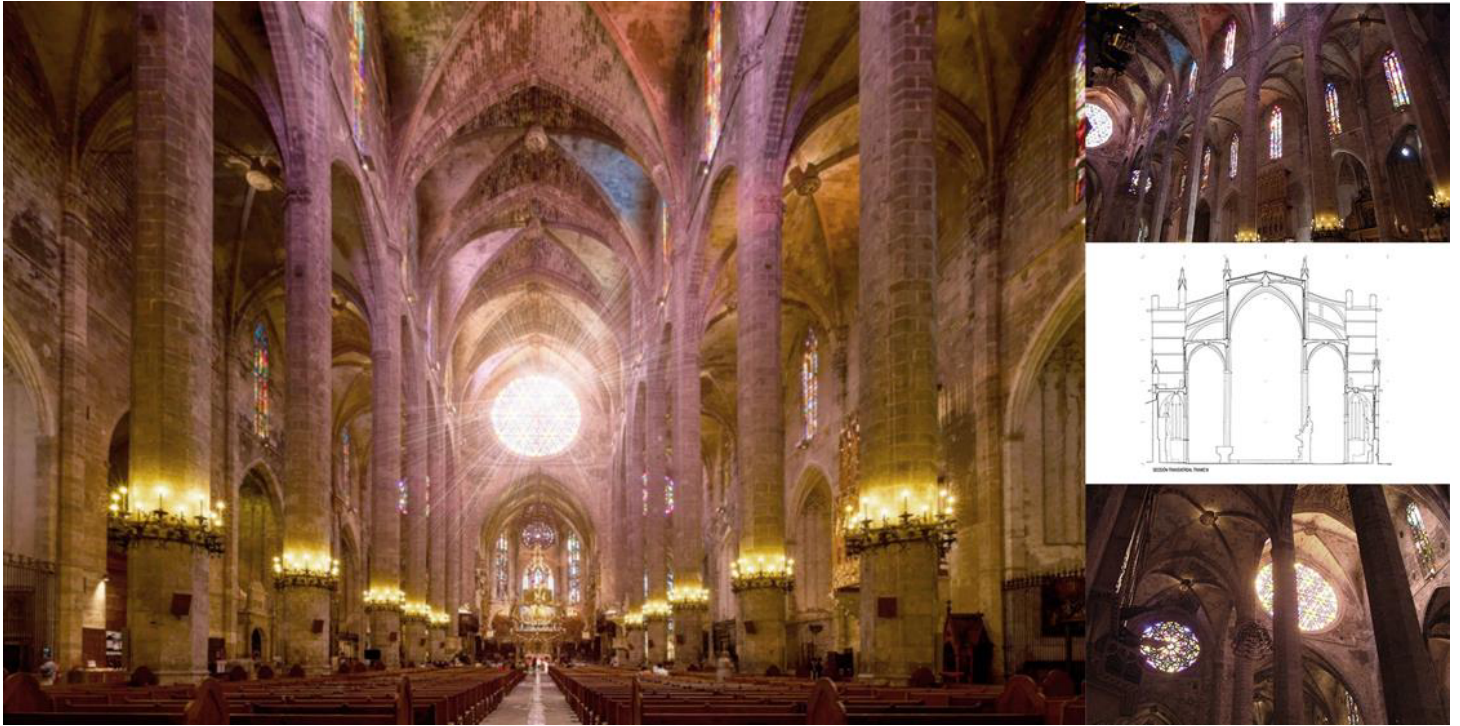
The columns of Palma de Mallorca Cathedral, which are the slenderest among Gothic Cathedrals in the world, showed curvatures in the vertical cross section as well as other damage (vertical cracks amongst others). This study was needed in order to establish the Management Program of the Cathedral. Likewise, disorders in the flying buttresses were also detected.

In order to find an answer to this problem, an analytical study of the cross sections structural behaviour was fulfilled. The mechanical behaviour of the masonry had to be characterized, as without recognizing the masonries and their resistant capacity, the degree of the columns' stability could not have been determined.

The structural analysis allowed an estimation of the safety level of the columns expressed in terms of relation between failure and acting stress eccentricities. The safety level determined was deemed to be adequate. In this study, the importance of the consideration of the construction process has been shown. With regard to the thrusts, whose analysis required fairly simple tools, (stability and tensional verification with non-tension materials) the study concluded that the stability of these elements would not be compromised whilst there were no movements in the abutments.

In any case, the need to develop an intelligent monitoring plan was observed in order to follow through and control the evolution of the most significant parameters in comparison with the correspondent threshold values.
