# Evaluation of 8 bridges in Indiana

Indiana, USA / 2006-2009

steel deck bridges and concrete columns  
rehabilitation project  
Indiana Toll Road (Ferrovial)  
Ferrovial  
inspection, diagnosis, and repair project

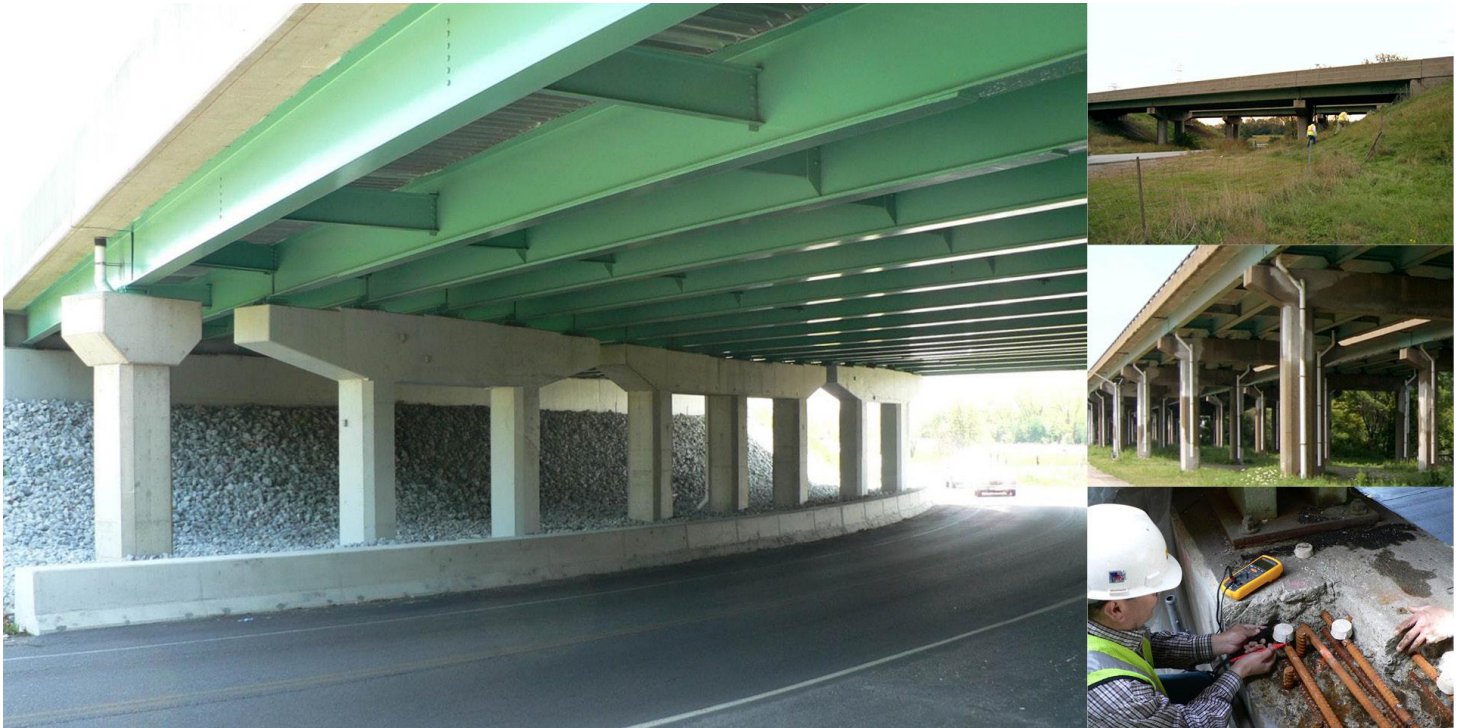
Within the Extension of Structures Project, an analysis has detected an important existing deterioration in the elements of the structures after 50 years of service, due to the salts in the freeze/thaw process.

The inefficiency of previous repairs has been analyzed due to the formation of macro-piling between the repaired area, which was anodic before repair, and the non-repaired, cathodic before intervention and becoming anodic.

After a thorough identification of the existing damages, an appropriate treatment has been implemented on each element, with a supposed 50 year life span. A special treatment has been designed to alleviate the effects produced by the salts in the freeze/thaw process, using cathodic protection to avoid the 'macro-pier' effect in the repaired areas. The novelty in the rehabilitation has been the implementation of zinc anodes, embedded in the highly alkaline mortar, which control the onset of corrosion.
