Los Madrazo Street Refurbishment

Madrid, Spain / 2019

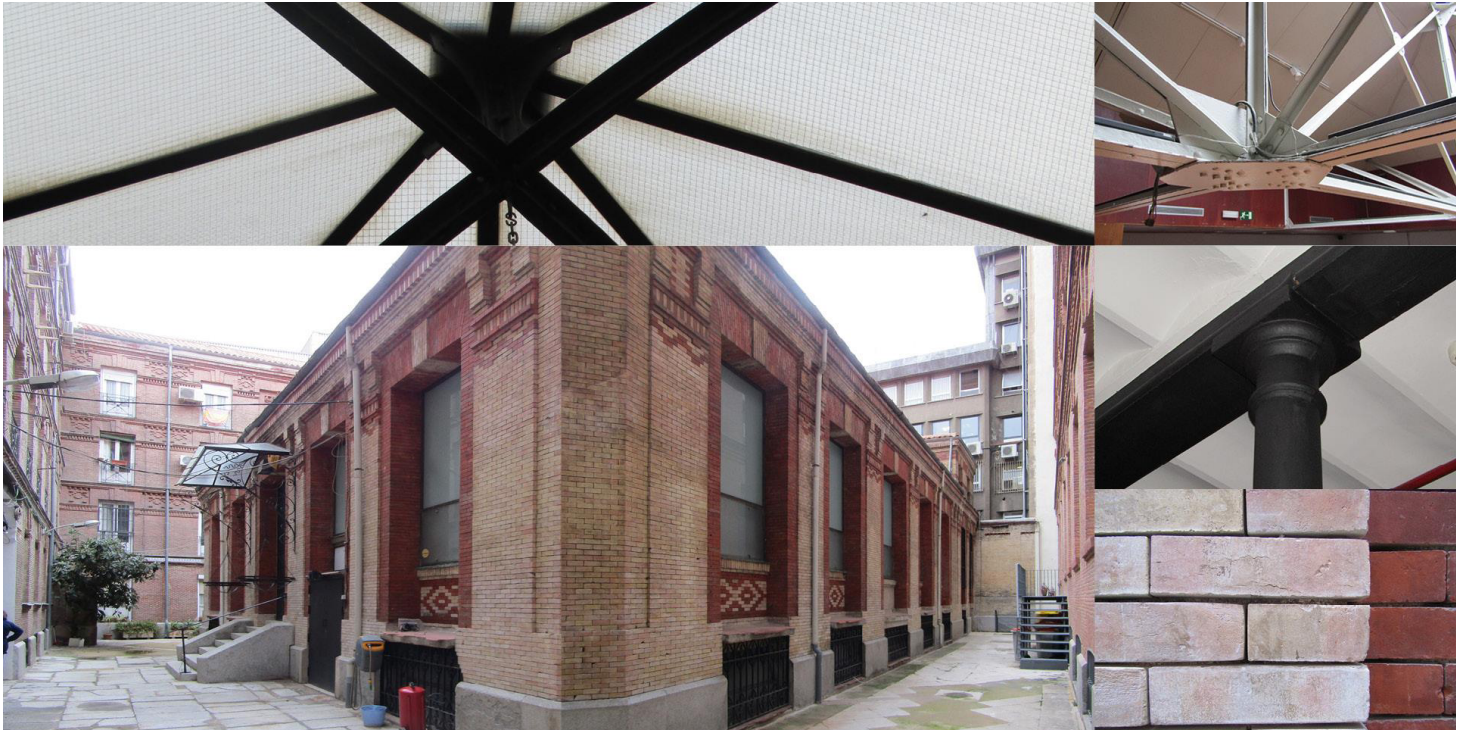
Load Bearing masonry walls with wooden columns. Steel and wooden joists floors
Los Madrazo 6, 8P and 10: IPN160 steel joists floors - Los Madrazo 8: wooden joists floors
Atalaya Zorrilla Madrazo
Fund FST
Espirea
detailed design and construction monitoring
Ruiz Barbarin Arquitectos
