## Rehabilitation of international railway bridge over Bidasoa river

Hendaya, France - Irún, Spain / 2017-2021

Length 114m, construction in 1860

Scope repair project and monitoring

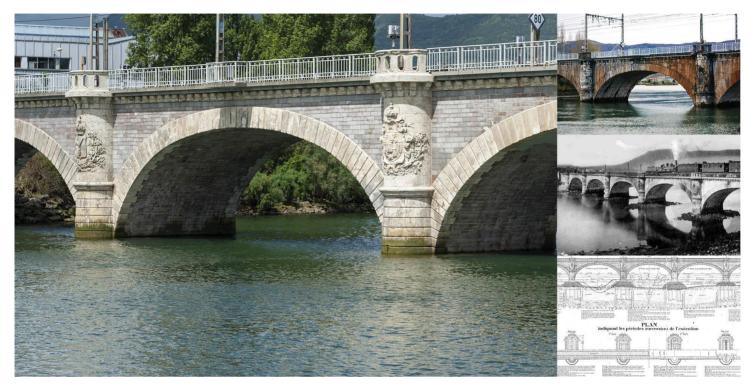
Designed by French engineers and completed in 1864, this example of the best stone bridge engineering has been restored according to FHECOR's design. Its 160 years of service are proof of the durability and sustainability of masonry bridges.

The €1.5 million investment has been divided between the restoration and the environmental integration actions in the bay of Txingudi. The faces of the vaults, spandrels, piers and abutments have been restored and the foundations have been protected with rockfill.

The project includes innovative stitching techniques using fibreglass rods coated in resin and sand. In the central vault, which was blown out in 1943 and replaced by a reinforced concrete thread, the restoration has involved adding an additional 10 cm of soffit with a configuration that reproduces that of the original ashlar masonry with hydraulic lime mortar.
