# Langa de Duero bridge

Langa de Duero, Spain / 2018-2020

Stone bridge rehabilitation  
Diputación de Soria  
inspection, diagnosis, and repair project

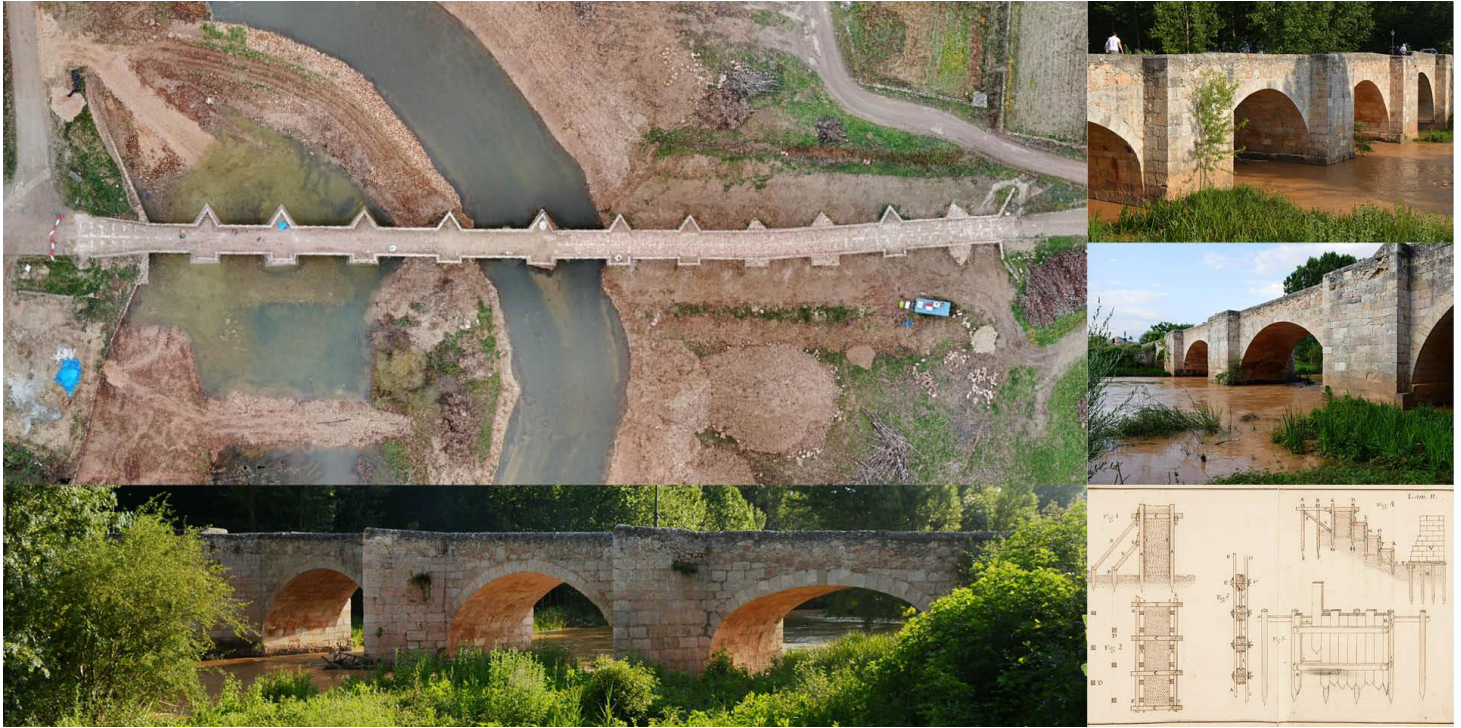
The bridge was built at the end of the 15th century. It is a 160m long factory bridge, divided into 11 barrel vaults, with 3 central arches. The three piers located in the natural course of the river have been the most affected during the centuries of history of the bridge, precisely because of its location.

The rehabilitation project was then drafted. Work was proposed to repair the damaged foundations and to improve the structural performance of the bridge, such as replacing the loose filling of the vaults with mass concrete.
